| <i>Seabed Sampling and Baited Camera Operations</i> | |
| Vessel | R/V Ocean Veritas |
| Summary Report Number | 06 |
| Operating equipment | MAXI Corer (8 core unit) |

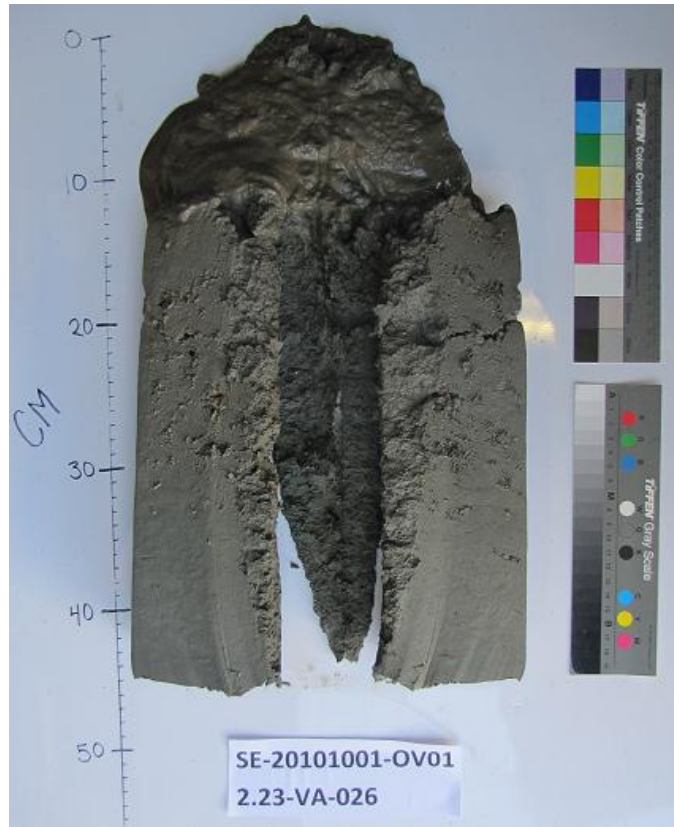
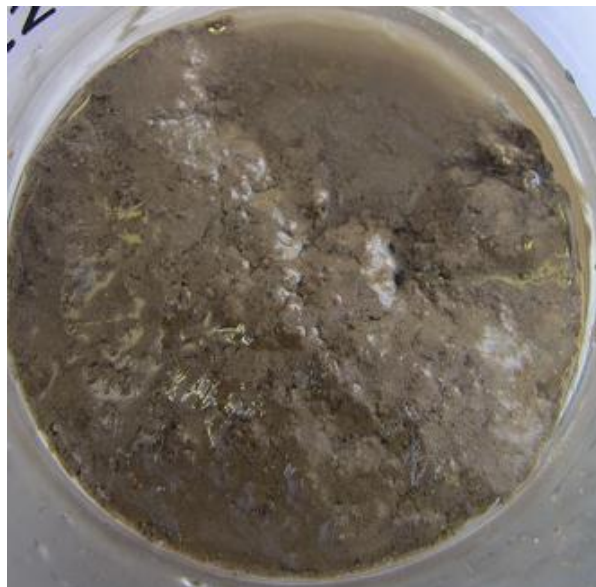
Station 2-23

Cores recovered: 7 out of 8

Recovery: 17 cm

Visible contamination: None

Recovery: 43 cm

Description: Olive brown fluidized sediment to approximately 2 cm depth. Olive grey, very soft homogenous silty clay becoming firm.

Biota: Shrimp.

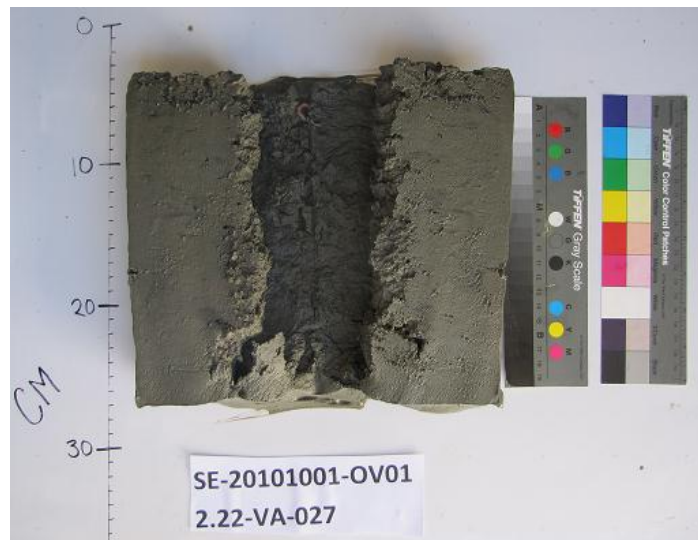
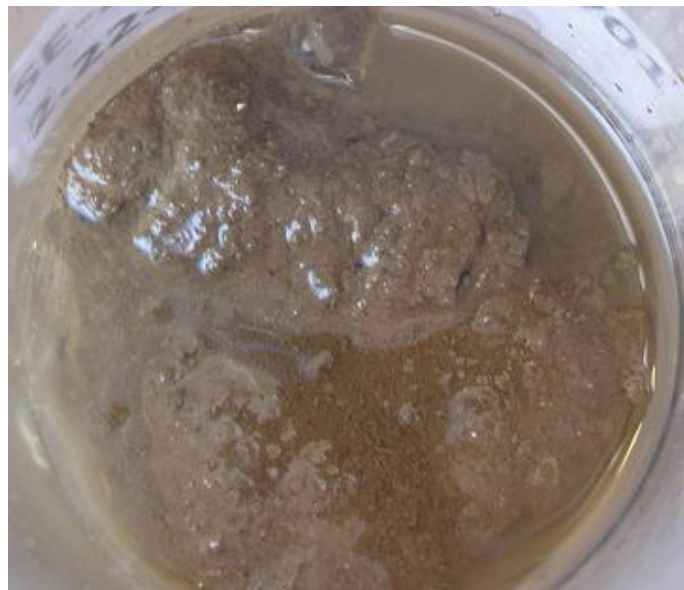
Station 2-22

Cores recovered: 8 out of 8

Recovery: 30 cm

Visible contamination: Thin layer of oil sheen on water surface.

Description: Brownish yellow fluidized sediment to approximately 4 cm depth. Olive grey, firm to stiff, homogenous silty clay, becoming soft with isolated organic patches throughout.

Biota: Worms.

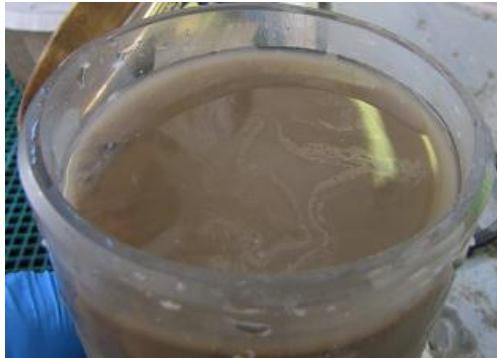
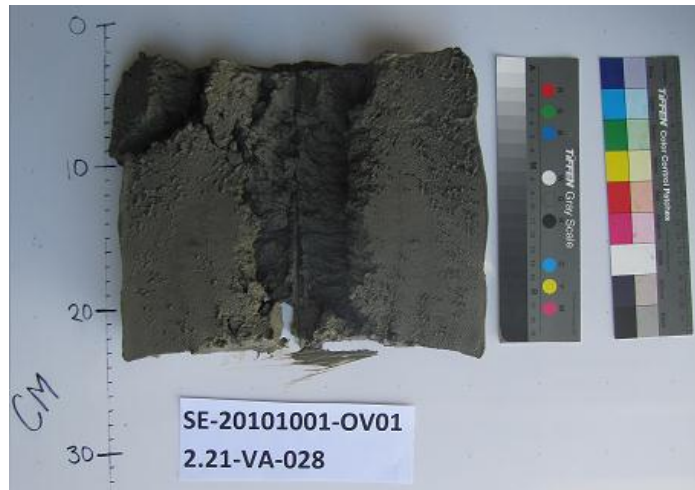
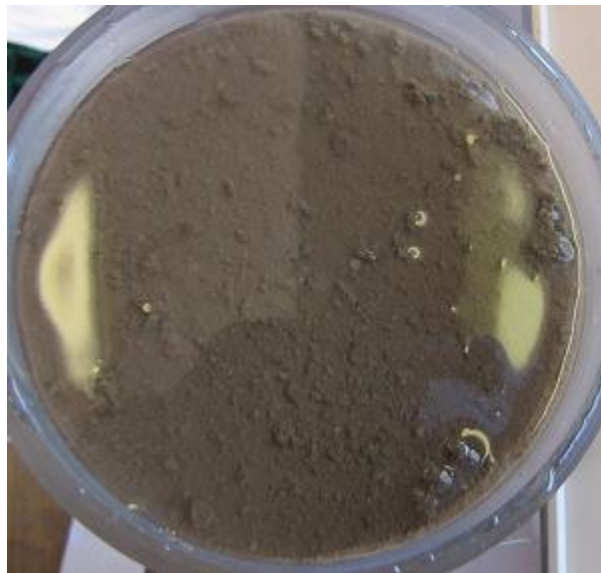
Station 2-21

Cores recovered: 8 out of 8

Recovery: 35 cm

Visible contamination: Thin layer of oil sheen on water surface.

Recovery: 25 cm

Description: Brownish yellow fluidized sediment to approximately 3 cm depth. Olive grey, very soft to soft, homogenous silty clay with a firm layer from approximately 10-20 cm.

Biota: Worms.

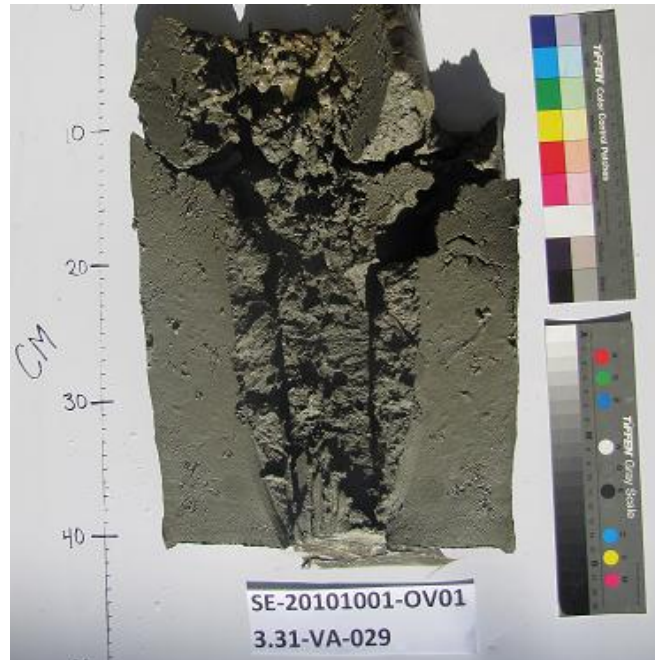
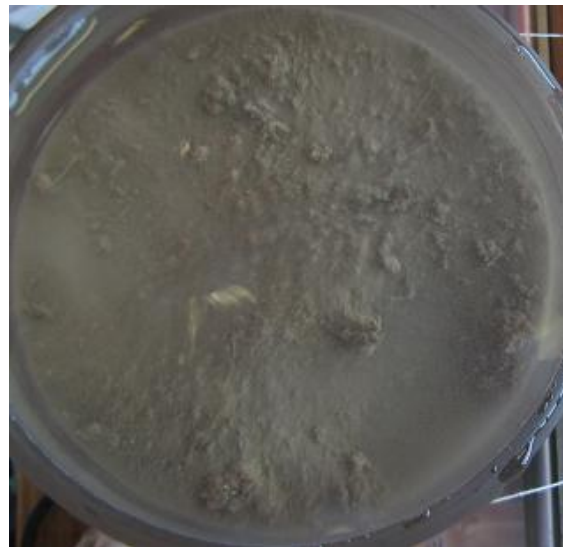
Station 3-31

Cores recovered: 8 out of 8

Recovery: 20 cm

Visible contamination: Thin layer of oil sheen on water surface.

Recovery: 40 cm

Description: Brownish yellow fluidized sediment to approximately 3 cm depth. Olive grey, very soft to soft, homogenous silty clay with a firm layer approximately 20-30 cm.

Biota: Worms.

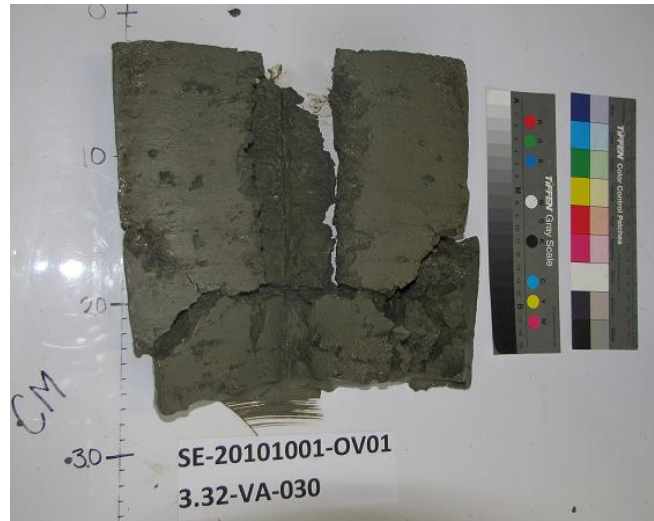
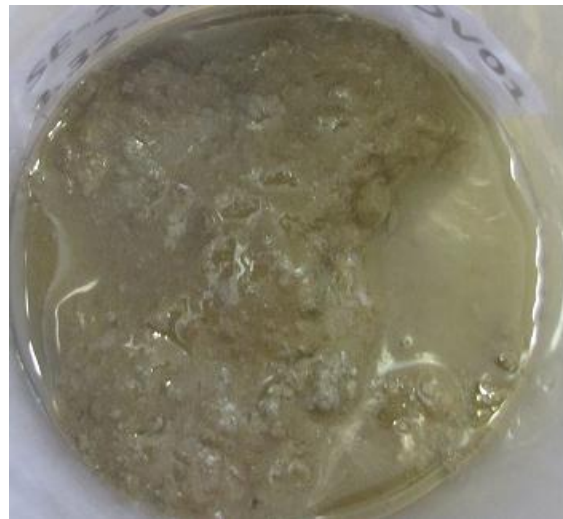
Station 3-32

Cores recovered: 8 out of 8

Recovery: 28 cm

Visible contamination: None

Recovery: 42 cm

Description: Brownish yellow fluidized sediment to approximately 3 cm depth. Olive grey, soft, homogenous silty clay, with a firm layer approximately 10-20 cm.

Biota: None.
